## **CASE HISTORY VINEYARD DRAINAGE - IDROSAC-MONTALCINO (SIENA)-TUSCANY-ITALY-2011**

### **1 - Description of the land defense intervention**

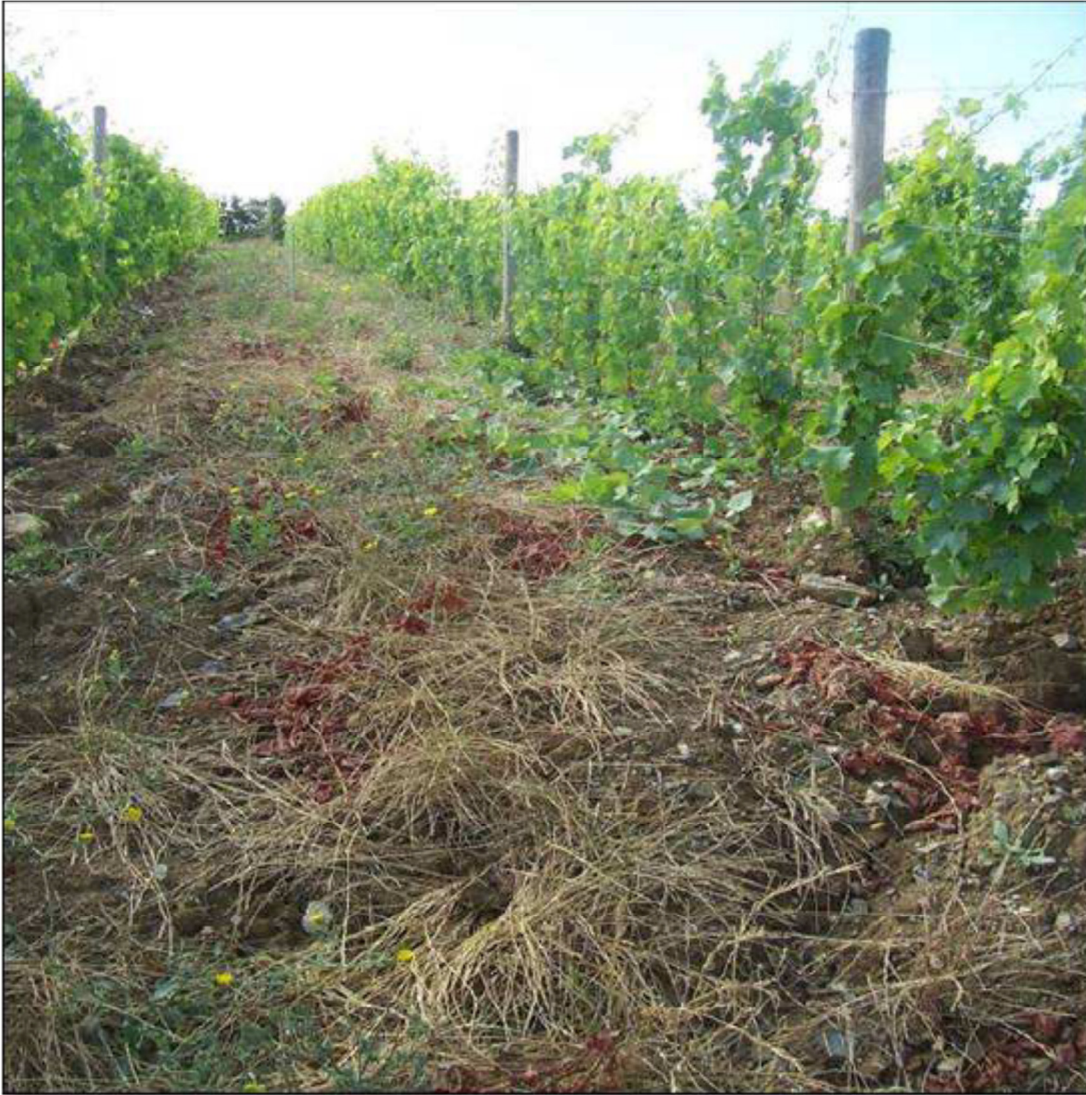
**Figure 1 - Movements of the land that have destabilized the vineyard.**

The purpose of the intervention is to achieve a shallow drainage in the trench using the IDROSAC 500 system. In detail it is necessary to drain the excess water to the contact between the schistose shales and the landfill, in order to stabilize the movement in act in the central portion of the vineyard, which caused damages to the new plant (Figure 1). From the information gathered from the property and from the insiders it appears that the area subject to intervention has always been for agricultural use with crops used in the sector of wine and the need for drainage is of primary importance in order to ward off the excess of water from the ground to improve its use and to safeguard the growth of water plants with a consequent increase in agricultural production and speeding up of operations agricultural.

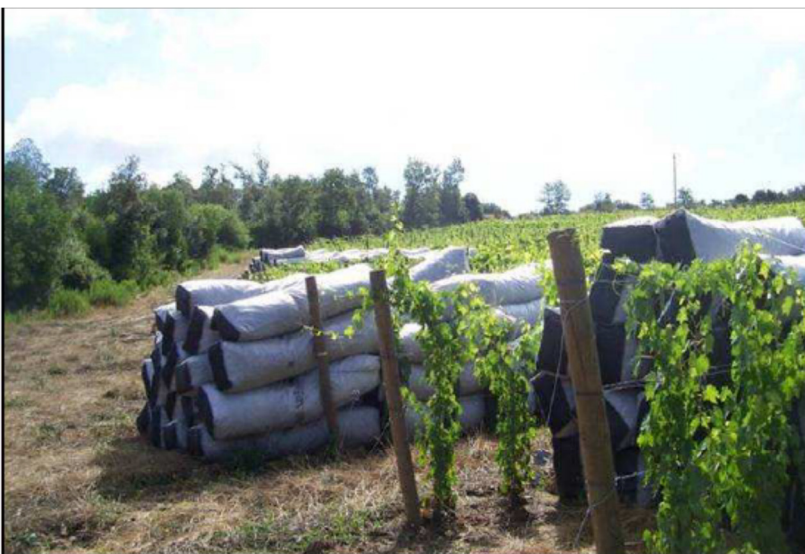
**Figure 2 - Flexible draining non-woven bags mod. IDROSAC 500 used**

The IDROSAC 500 system (Figure 2) was chosen both for the lightness and versatility of the material as for the logistics of the intervention area that had to be minimally invasive in order to preserve the state of the vines and do not damage the end posts, columns, or rows, etc..

Because of this, IDROSAC flexible bags have proven to be easily transportable by hand Rows, otherwise it would have been for gravel wheelbarrows and / or PVC pipes that would have involved: attentions, times and efforts certainly greater.

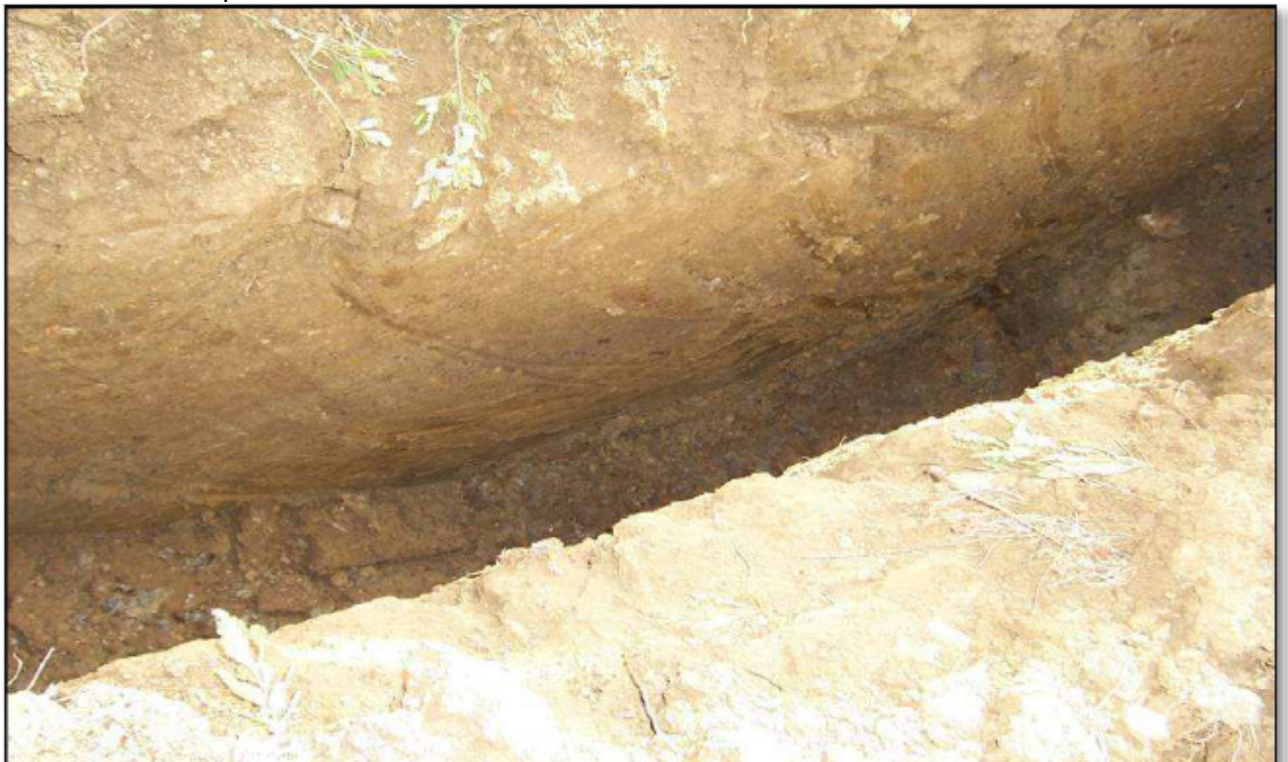
**Figure 3** - Excavation with a mechanical excavator for the installation of the IDROSAC 500 system at the Montalcino estate (SI).

The first phase of work was the realization of the excavation excavation by excavator mechanical equipped with universal digging bucket (Figure 3). Taking account of the foregoing the excavation operation has saved the need to intervene with earth movements reduced to minimum to preserve the present cultures from damage. Based on the explorative essay performed with

the excavator and taking into account the operational needs of the client (at least 1 m franc lateral from the rows of vines to guarantee future operations of vineyard processing) the Director Works (DL), considered a surface possible of dissection next to the meter and a half. So it was decided to make an excavation between the rows (18 in total) with a 40 cm bucket until reaching the vineyard slope downstream the drained water flows out of the unstable area. To facilitate the subsequent laying of the bags draining was advised to pay attention to the profile of the excavation walls and to refine the bottom of the same so that it turns out more flat and horizontal and less loose as possible.

With regard to the excavation support works, they have not been necessary since the same settling on compact clayey lithologies at a maximum height of 1.5 m. from the p.c. is stable result.

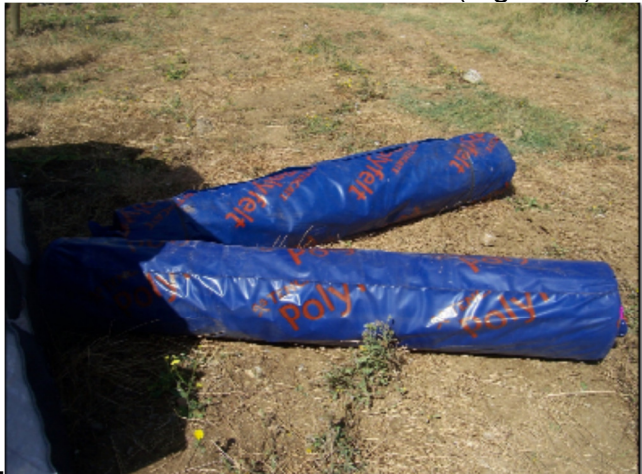
**Figure 4 -** Pieces of geotextile of the type non-woven fabric (TNT) used for cover IDROSAC 500 draining bags at the estate in Montalcino

The DL considered it appropriate to use a layer of geotextile (Figure 4) of the type non-woven fabric (TNT) 2 m wide as IDROSAC 500 draining bags casing.

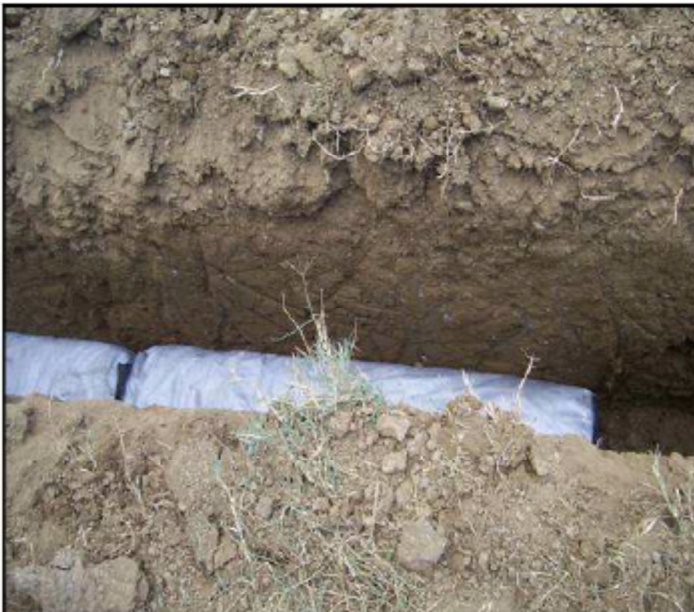
**Figure 5 –** Positioning of draining bags IDROSAC 500 at the bottom of the trench

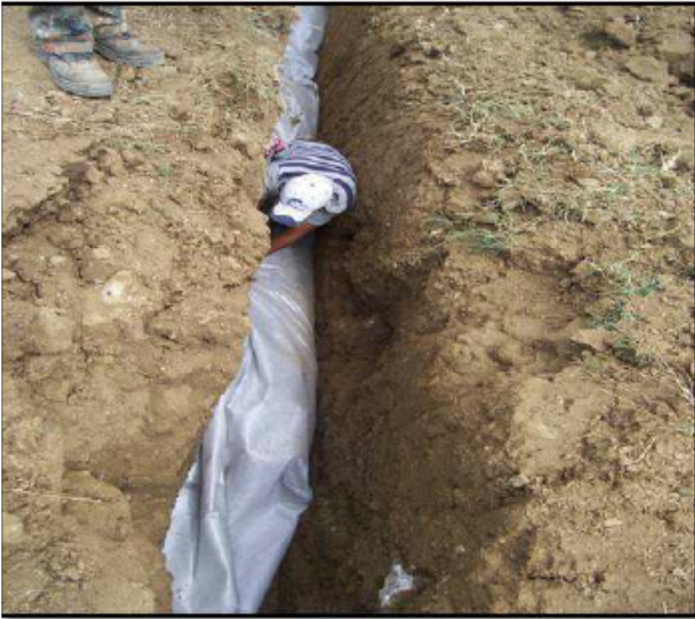
**Figure 6** – Lining operation  
draining bags with the TNT carried out manually inside the trench

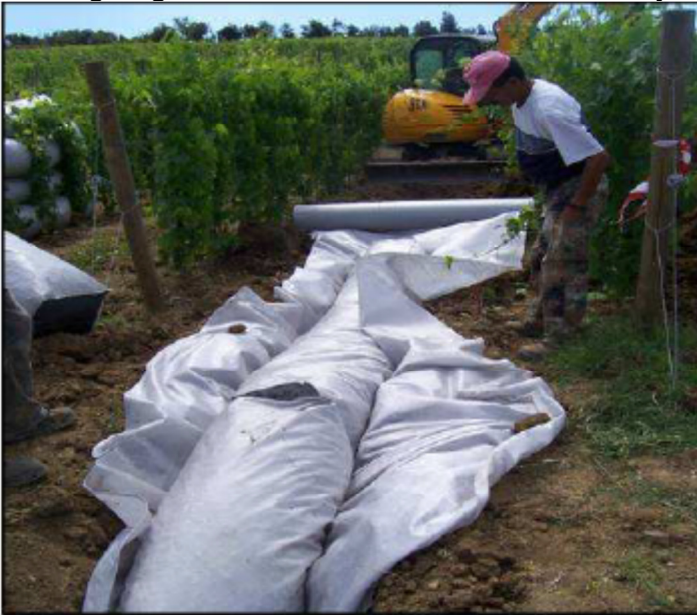
**Figure 7** – Drawing up the TNT patch so  
longitudinal with respect to the excavation directrix

The DL decided the laying system along the direction of the excavation (Figure 7 draining bags). Once the draining bags were laid, the manual closure of the TNT was carried out above the sack itself (Figure 8)

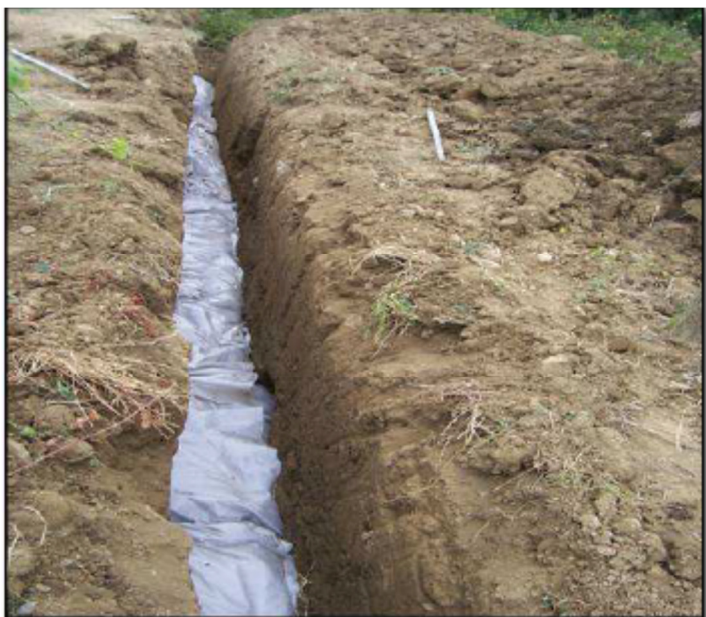
**Figure 8 –**

Manual closure of the TNT above the IDROSAC 500 draining bag
